DEPARTMENT OF TRANSPORTATION

Quality Assurance and Source Inspection

Contract #: 04-0120F4Cty: SF/ALA Rte: 80 PM: 13.2/13.9File #: 69.28**WELDING INSPECTION REPORT****Resident Engineer:**Pursell, Gary**Address:** 333 Burma Road**City:** Oakland, CA 94607**Report No:** WIR-008066**Date Inspected:** 29-Jul-2009**Project Name:** SAS Superstructure**OSM Arrival Time:** 700**Prime Contractor:** American Bridge/Fluor Enterprises, a JV**OSM Departure Time:** 1900**Contractor:** Zhenhua Port Machinery Company, Ltd (ZPMC), Changxing Island **Location:** Shanghai, China**CWI Name:** Ma Yun, Chen Ying Xin.**CWI Present:** Yes No**Inspected CWI report:** Yes No N/A**Rod Oven in Use:** Yes No N/A**Electrode to specification:** Yes No N/A**Weld Procedures Followed:** Yes No N/A**Qualified Welders:** Yes No N/A**Verified Joint Fit-up:** Yes No N/A**Approved Drawings:** Yes No N/A**Approved WPS:** Yes No N/A**Delayed / Cancelled:** Yes No N/A**Bridge No:** 34-0006**Component:** Tower**Summary of Items Observed:**

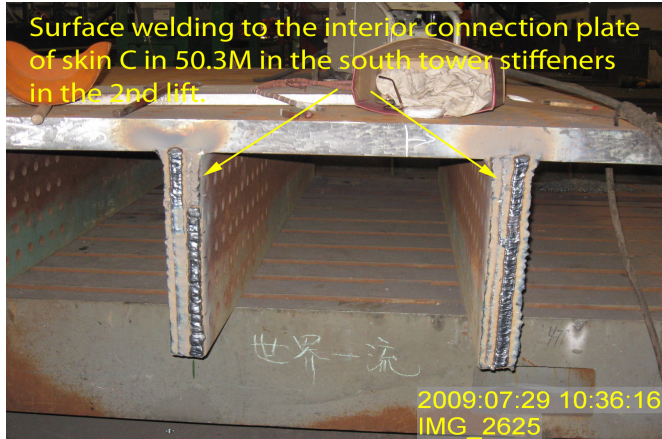
South Tower Lift 2 Skin C of Interior Connection Plate (WRR No. T-WR1853)

This QA inspector observed the surface welding to the interior connection plate of skin C in 50.3M in the south tower stiffener in the 2nd lift, which has insufficient size from one end to the machined size. FCAW welding located on SSD1-SA106, welders are identified as 070217 and 066695. ZPMC CWI is identified as Mr. Li Ming and the welding variables recorded by QC appeared to comply with WPS-345-FCAW-3G (3F)-Repair. 15mm surface welding is needed, including the skin plate and stiffener as per the welding repair report. For more details please refer to the attached pictures.
